**IPC TECHNICAL PAPER SERIES  
NUMBER 202**

**CORROSION BY KRAFT PULPING LIQUORS**

**R. A. YESKE**

**OCTOBER, 1986**

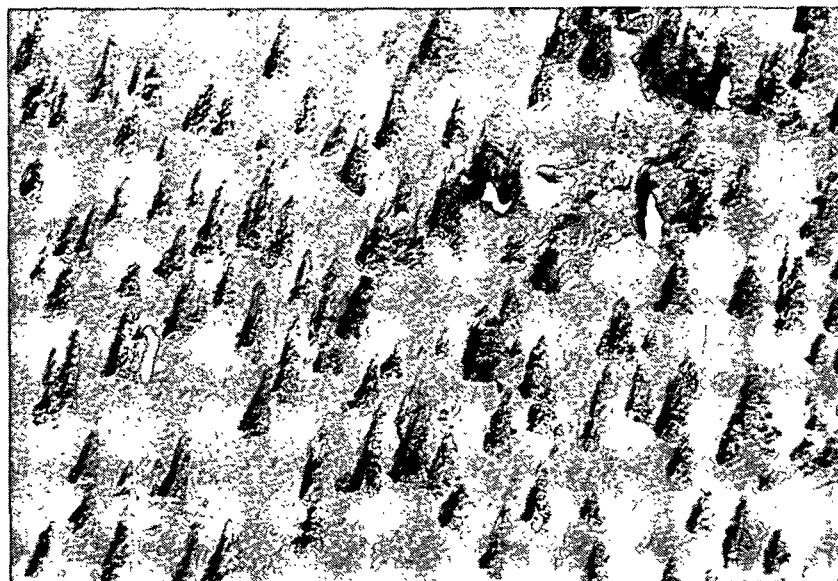
Figure 2. Erosion-corrosion of a blow target plate by pulp discharged at high velocities from a batch digester.

Blow Target Plates. Erosion-corrosion of the target plate in blow tanks is a continuing maintenance problem, but some advantage can be obtained by using exotic alloys. For example, Hastelloy® C276, a Ni-Cr-Mo alloy, has endured for four years in target plate service where 18-8 stainless steels were lasting for only a few months.

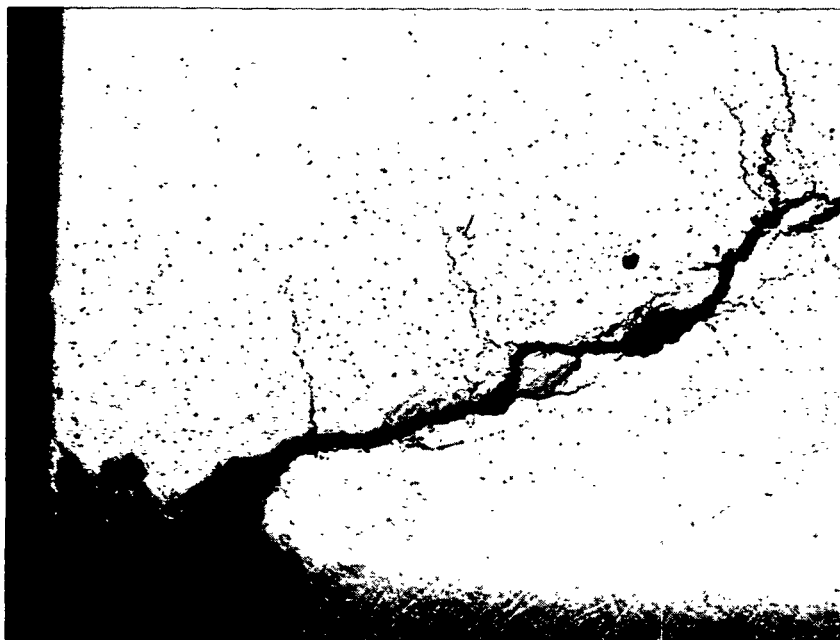
Figure 3. Macrograph showing cracking in a sample taken from a continuous digester weld.

Subsequent inspections of similar digesters revealed that more than half of the 140 continuous digesters operating in North America exhibited cracking in structural welds (21). Cracking has been found in girth and vertical shell welds, attachment welds inside the digester, and nozzle welds. Both longitudinal and transverse cracking have been observed, but the deepest cracking has been found in longitudinal cracks in the weld heat-affected zone. Examples of cracking in actual digester welds are shown in Figures 3 and 4.

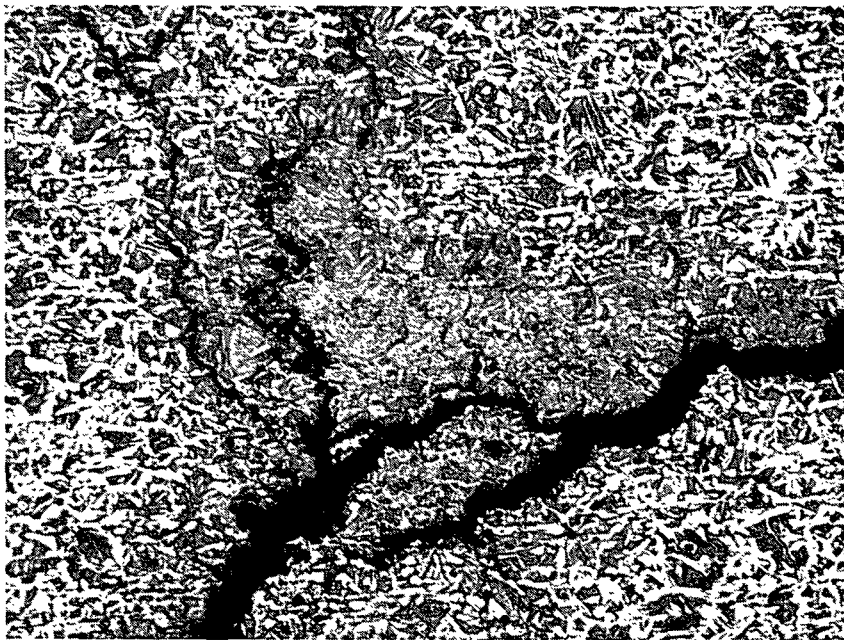
Figure 4. Photomicrograph showing branched, intergranular nature of cracking in an actual continuous digester weld.

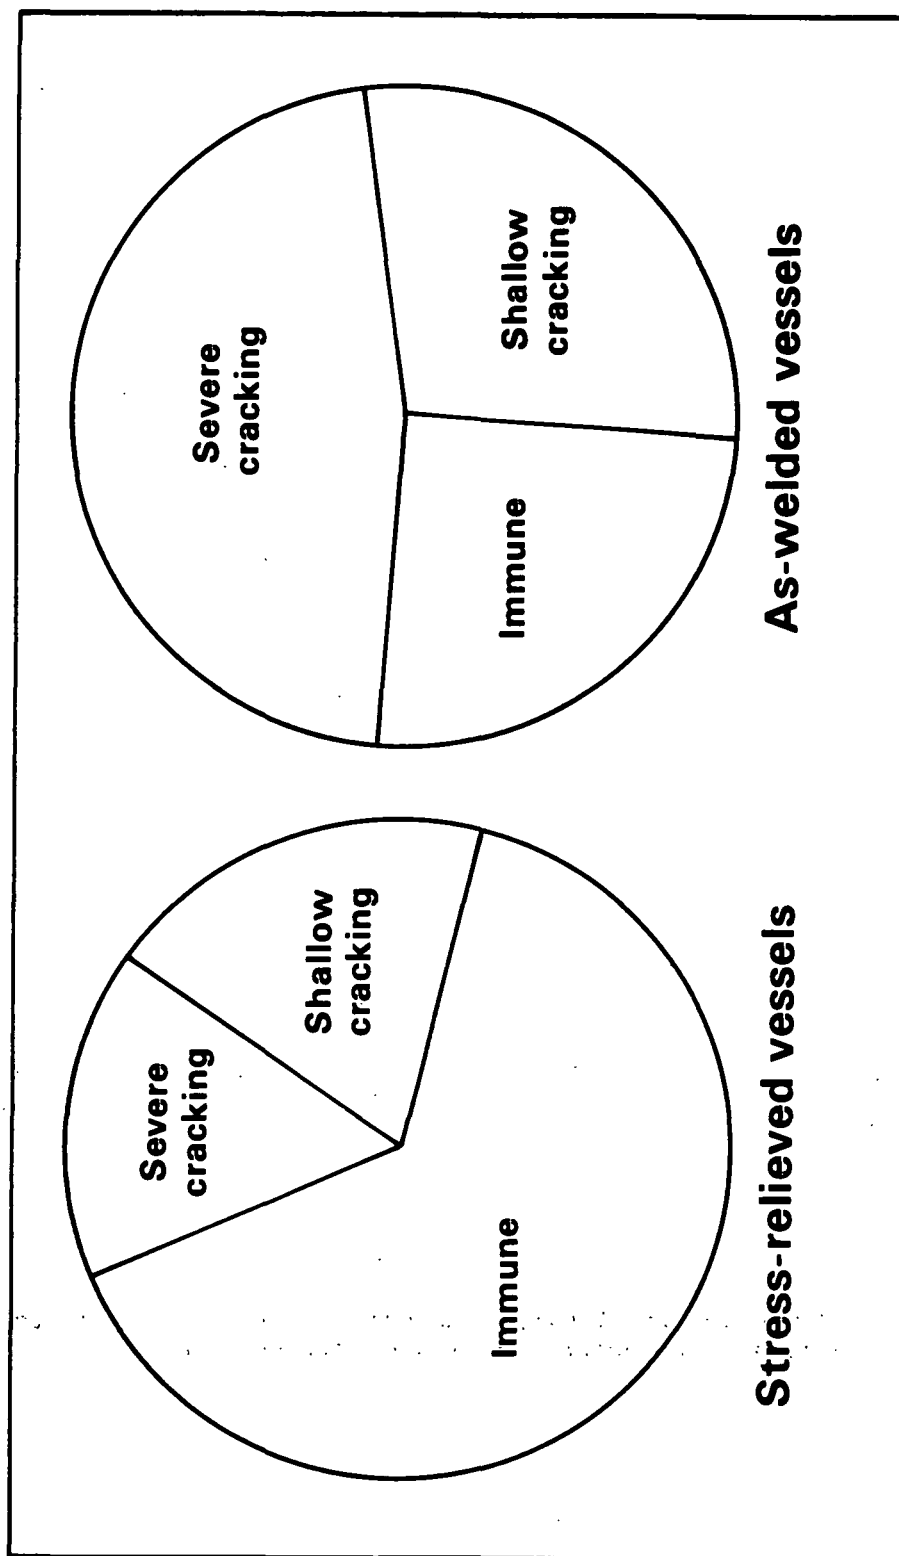
Figure 5. Effect of stress relief on stress corrosion cracking susceptibility of continuous digesters.

An extensive survey of digester cracking statistics failed to reveal differences in digester design or operation that would account for differences in cracking susceptibility (21). As shown in Figure 5, post-weld heat treatment significantly reduced, but did not eliminate, susceptibility to severe cracking.

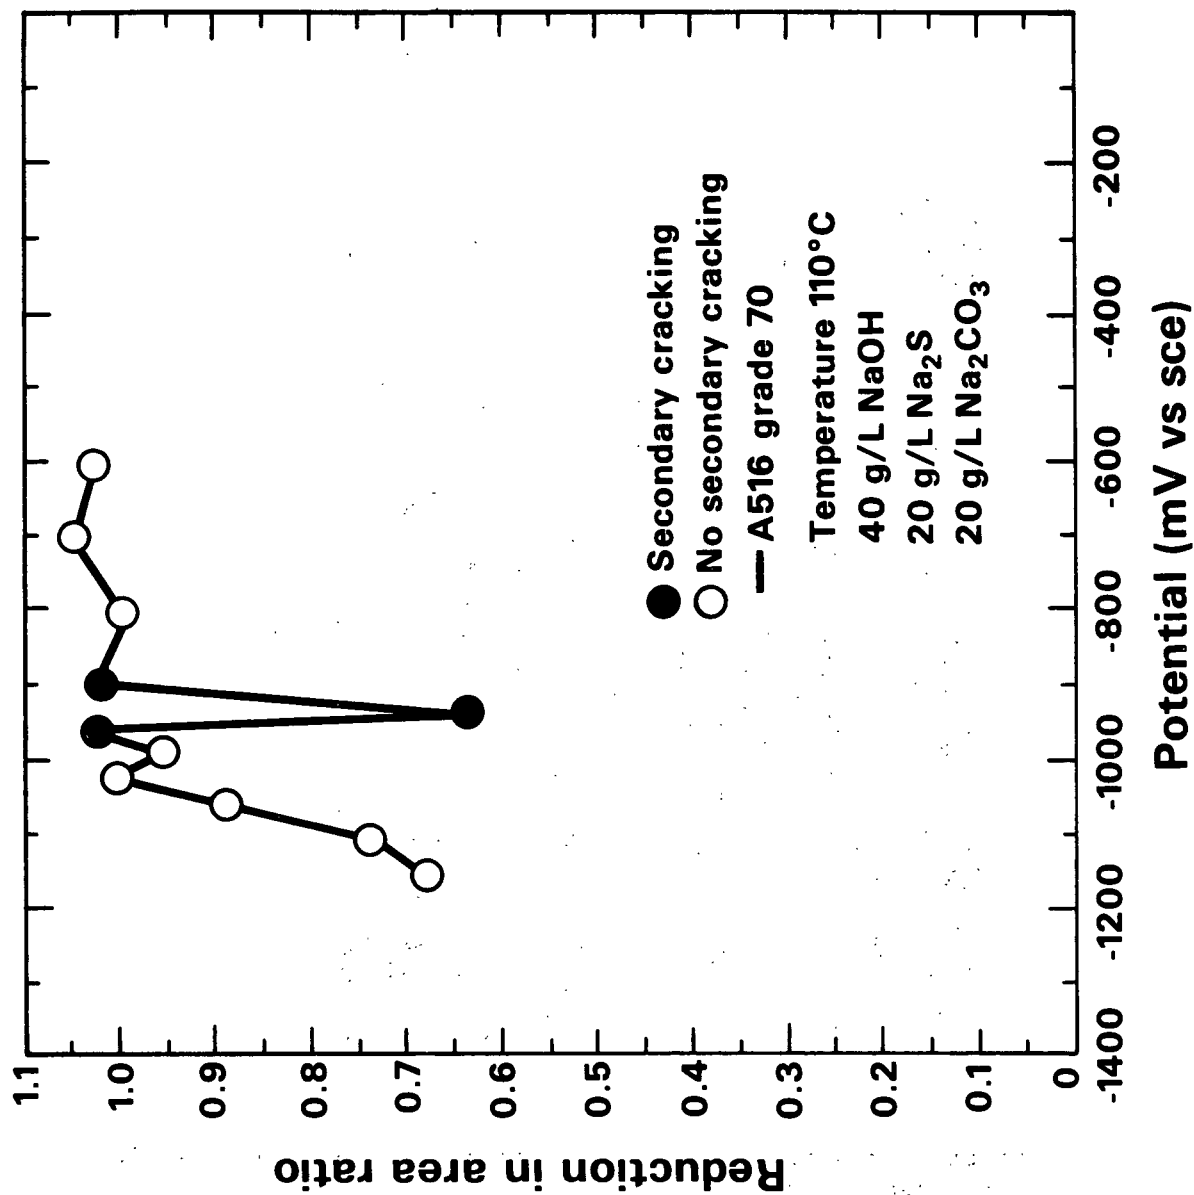
Figure 6. Plot showing the effect of potential on cracking severity in controlled-potential slow strain rate testing of digester steels exposed to a simulated impregnation zone liquor.

Cracking similar to digester cracking was reproduced in the laboratory using accelerated slow strain rate and fracture mechanics tests (22). These tests indicated that the caustic concentration in cooking liquors at the impregnation zone was sufficient for caustic cracking of pressure vessel weldments. Furthermore, caustic cracking only occurred when the potential of the digester steel was within a 100 mV range centered close to digester potentials. Figure 6 shows the dependence of cracking susceptibility on potential as determined in slow strain rate tests performed on welded specimens in simulated impregnation zone liquor (23). Potential measurements made on an operating digester indicated that the digester rest potential remained above the cracking range, except for a few days following an upset in operating routine (24).

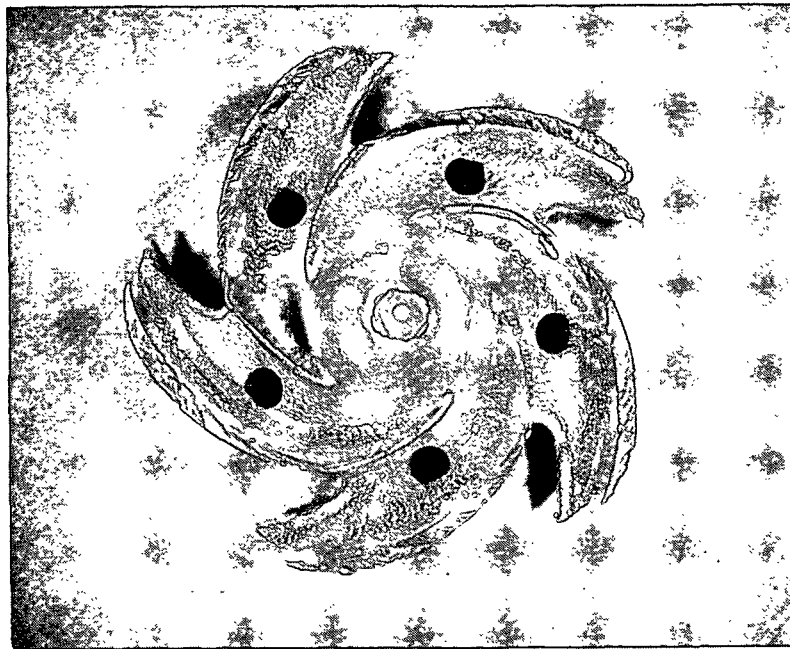
Figure 8. Erosion-corrosion of a lime mud pump impeller.

Erosion-corrosion is a severe problem wherever abrasive lime mud is found. Stainless steel fabrication is appropriate wherever abrasive conditions prevail, as in rakes and rake arms in white and green liquor clarifiers. In severely abrasive conditions, such as lime mud pump impellers, hard-facing overlays such

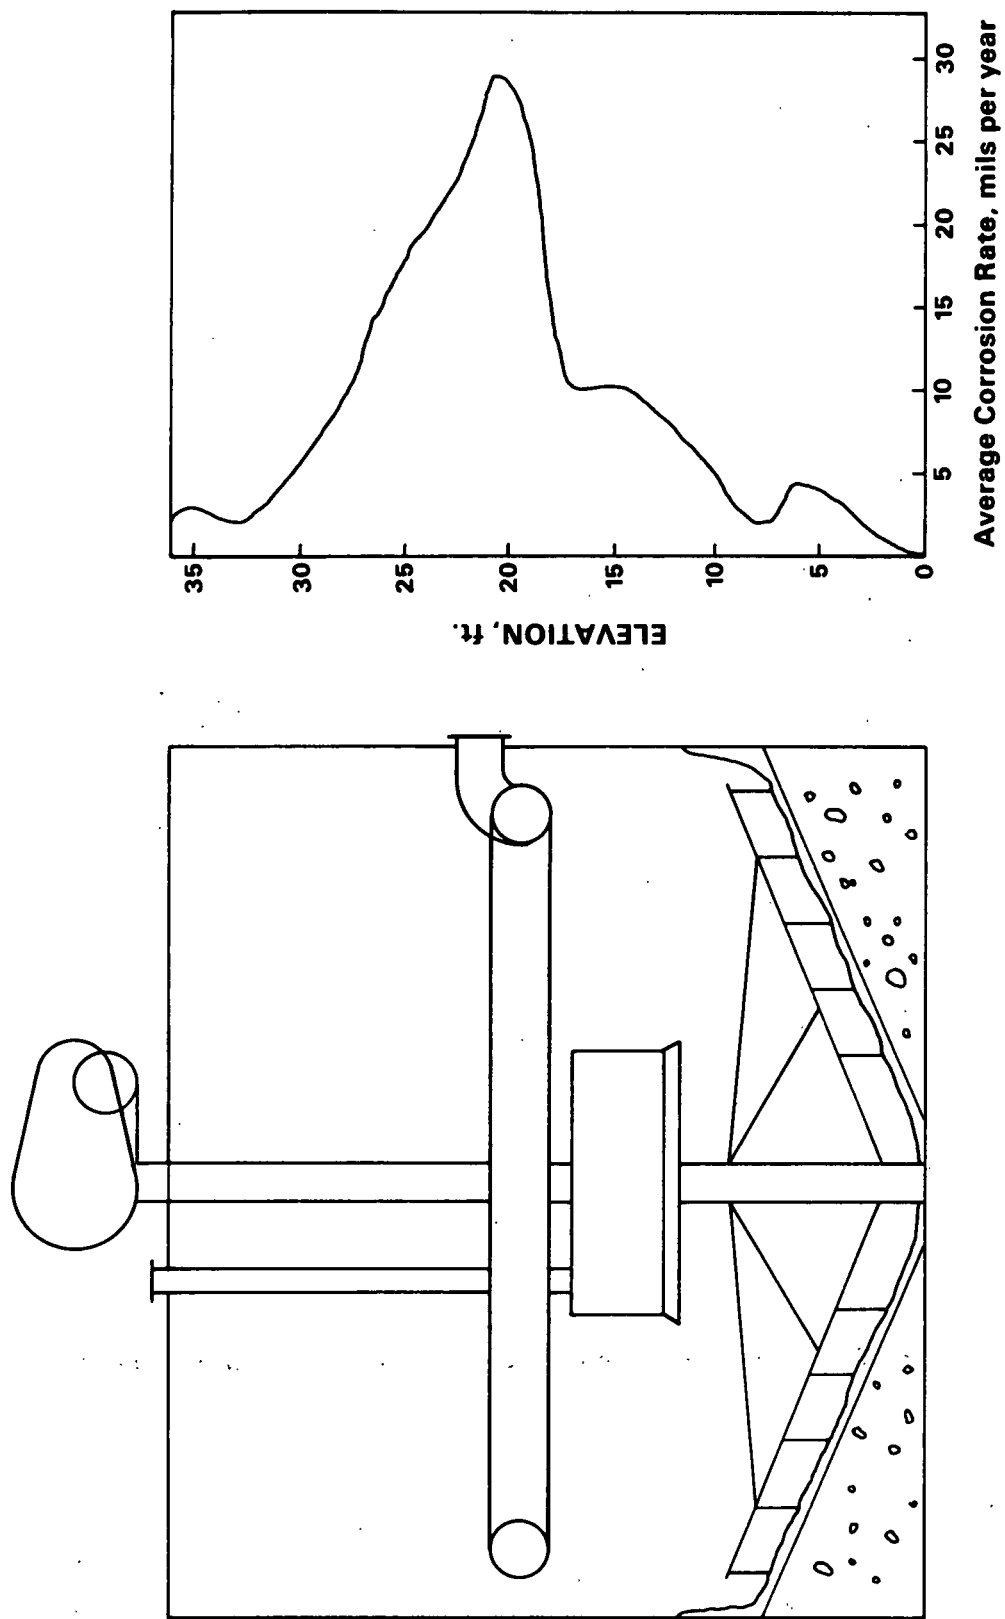
Figure 9. Variation of corrosion rate with elevation at the wall of a white liquor clarifier.

Plain carbon steel storage tanks and clarifiers in white and green liquor service suffer severe corrosive attack, particularly in zones where liquor levels fluctuate frequently. Figure 9 shows the variation in corrosion rate at different elevations along the sidewall of a white liquor clarifier (29). In the zone immediately above the outlet bustle pipe, the corrosion rate approaches 30 mils per year. Areas which are seldom immersed experience a much lower rate of corrosion, as do surfaces near the bottom which are protected by a layer of lime mud sediment. In multitray clarifiers, the trays experience a similar form of

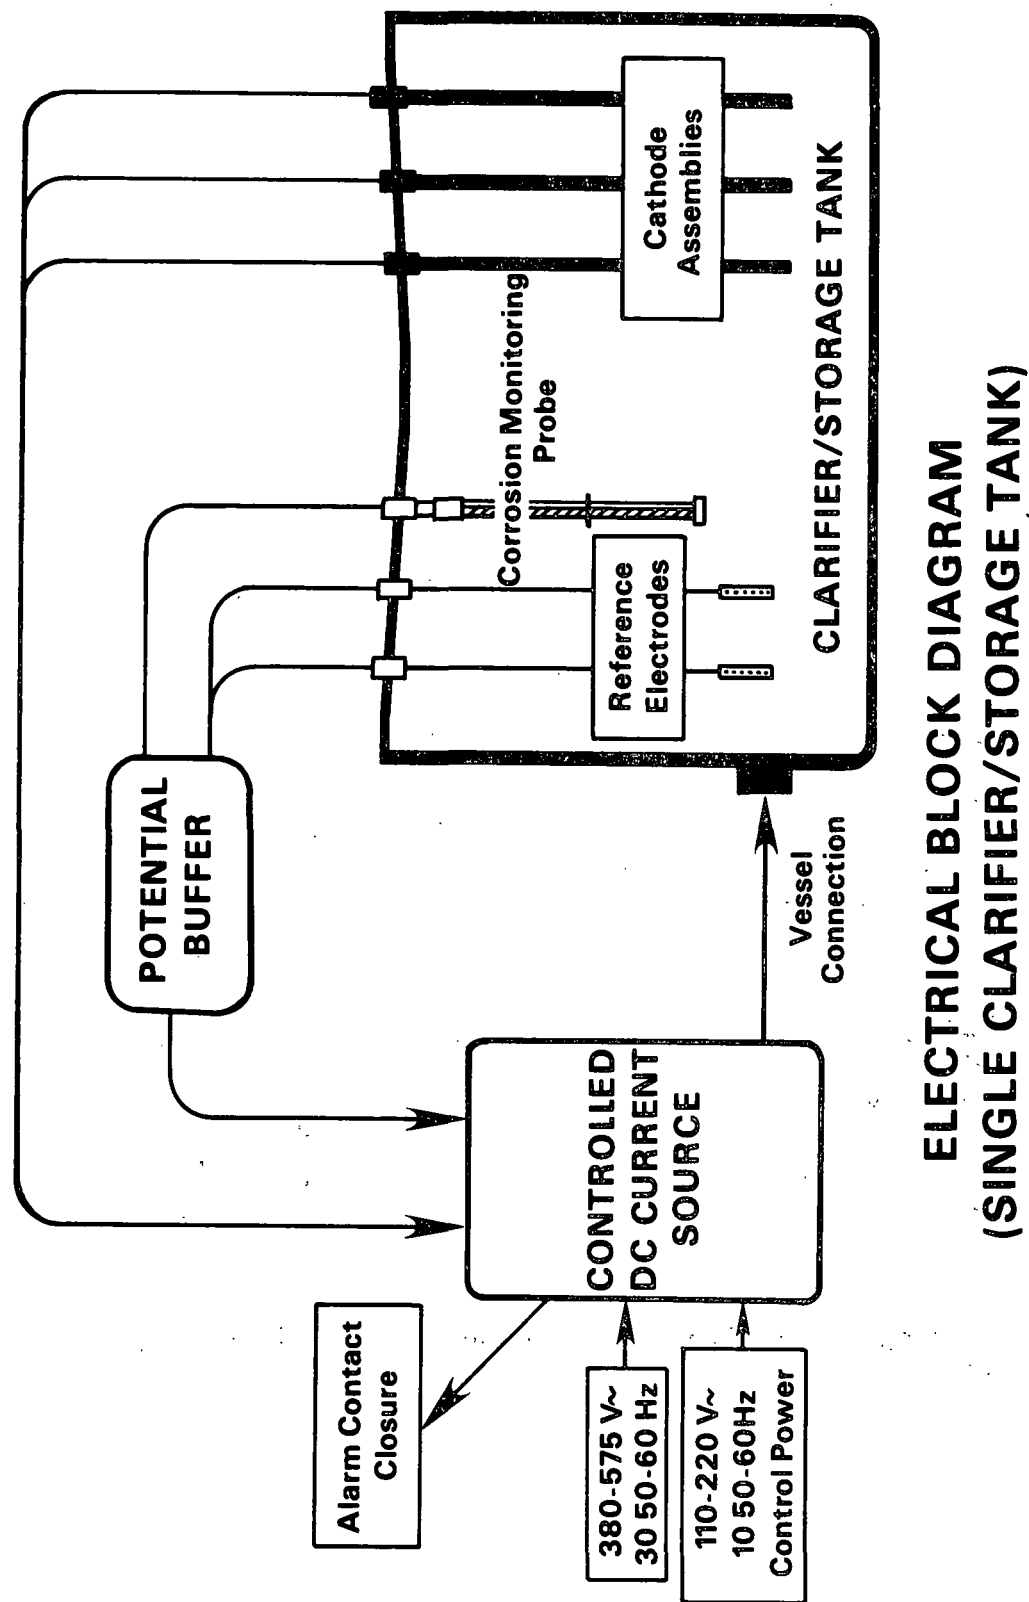
Figure 10. Schematic diagram of an anodic protection system for recausticizing storage tanks and unit clarifiers.

Recently, anodic protection has been shown to be an effective and economical corrosion control measure for use in white liquor storage tanks and clarifiers (29). In a prototype installation on an operating clarifier with severe corrosion damage, corrosion rates were reduced by nearly an order of magnitude by holding the rest potential of the vessel in the passive range. The anodic protection system is shown schematically in Figure 10. Although relatively large currents were required to achieve initial protection, little power is needed to maintain protective passivation.
